EK-MS88C-MI-001

# MS88-CA Memory Array Module

Maintenance Advisory

First Edition, January 1987

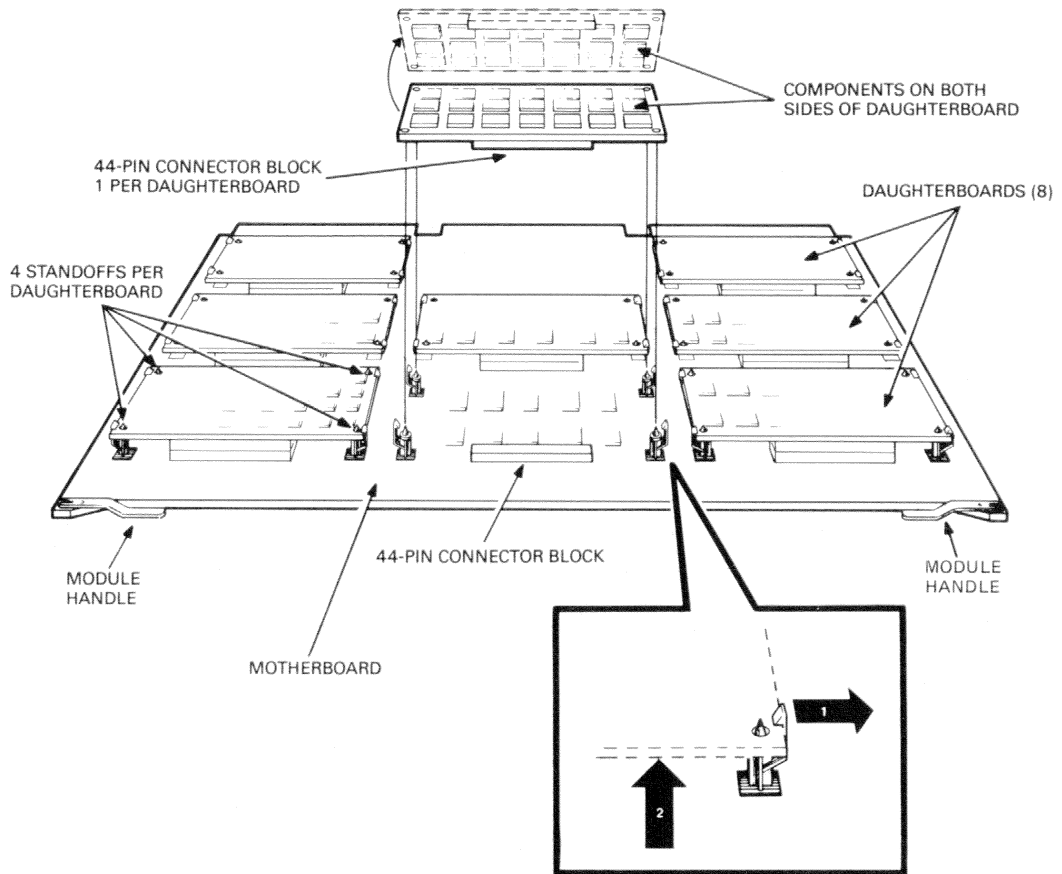
Figure 4-1 Eight Daughterboards on the Motherboard

Figure 4-1 shows the placement of the eight daughterboards on the motherboard.

7. To remove the desired daughterboard from the motherboard, push back the four corner standoff latches. Then gradually work the daughterboard up from the motherboard connector.

To install the spare daughterboard, perform this procedure in reverse. Be sure to place the removed daughterboard in the ESD container.

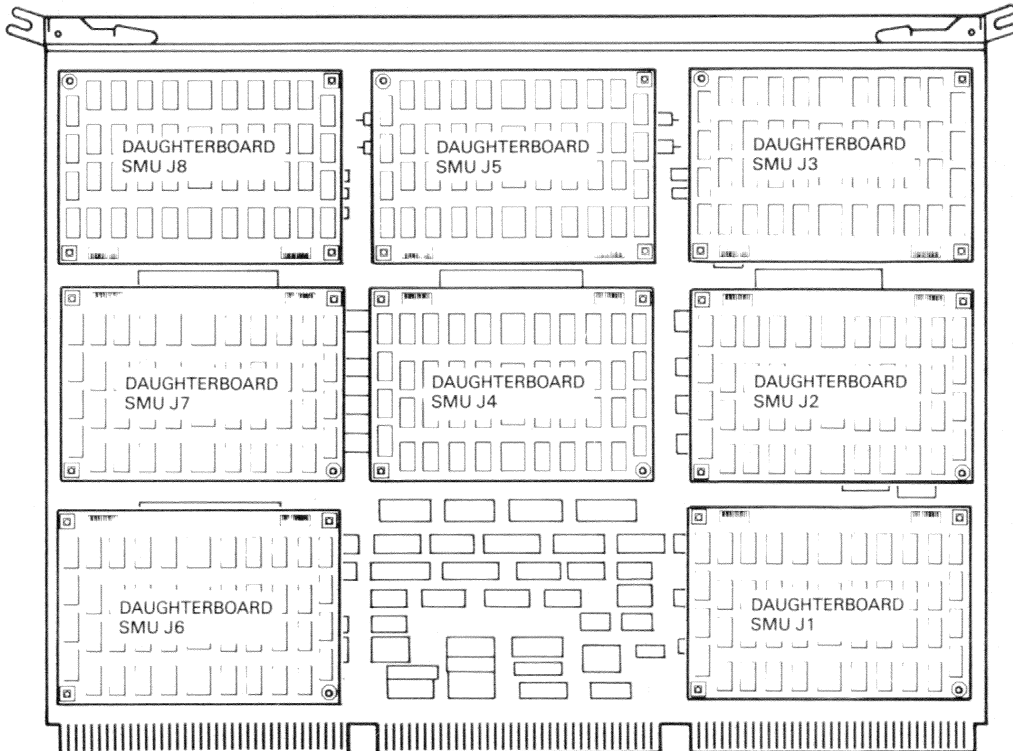
Figure 7-1 MS88-CA Module (Component Side)

On detection of an error, the MCL module saves the error page address in MEMORY CSR 1 (address 3E000004). NMI ADDRESS <03:02> H is stored in CSR 1 <31:30> as the word count. These two bits identify the failing bank or daughterboard pair.
