UDA50 Maintenance Guide

Digital Equipment Corporation
Colorado Springs, Colorado

First Edition, February 1982
Second Edition, November 1982
Third Edition, December 1984

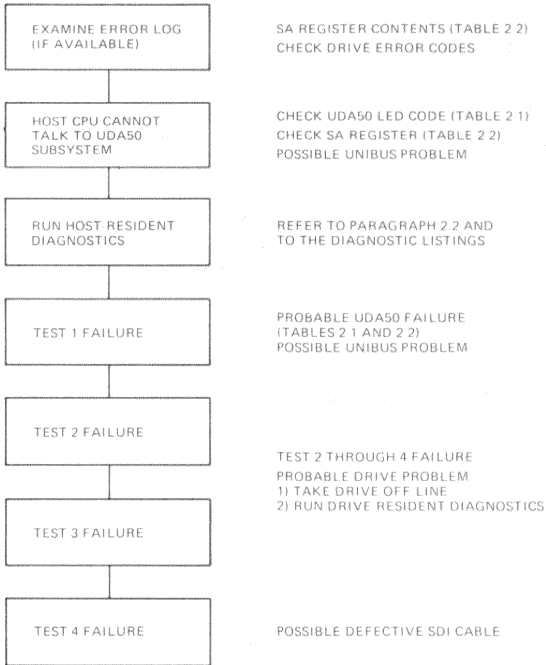
CX-489A

A brief UDA50 subsystem troubleshooting flowchart is illustrated in Figure 2-1.

Figure 2-1 UDA50 Subsystem Troubleshooting Flowchart
